## MAINTENANCE AND CONSERVATION WORKS IN THE CASTLE BATHS AT THE ŁAŃCUT CASTLE MUSEUM

*Alicja Mogielska-Dziekońska*  
*Łańcut Castle Museum*

*Wilanów Studies*  
vol. XXXII, 2025, pp. 433–463  
Yearbook, E-ISSN: 2720-0116

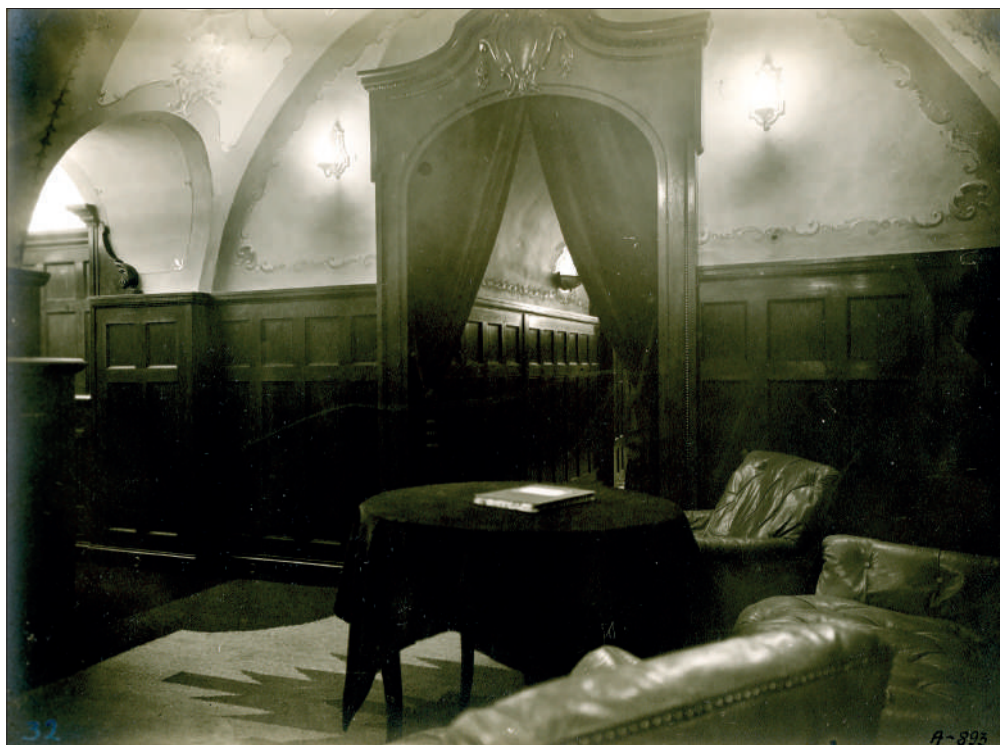
Fig. 1

Resting room, archival  
photograph, Łańcut Castle  
Museum Archive

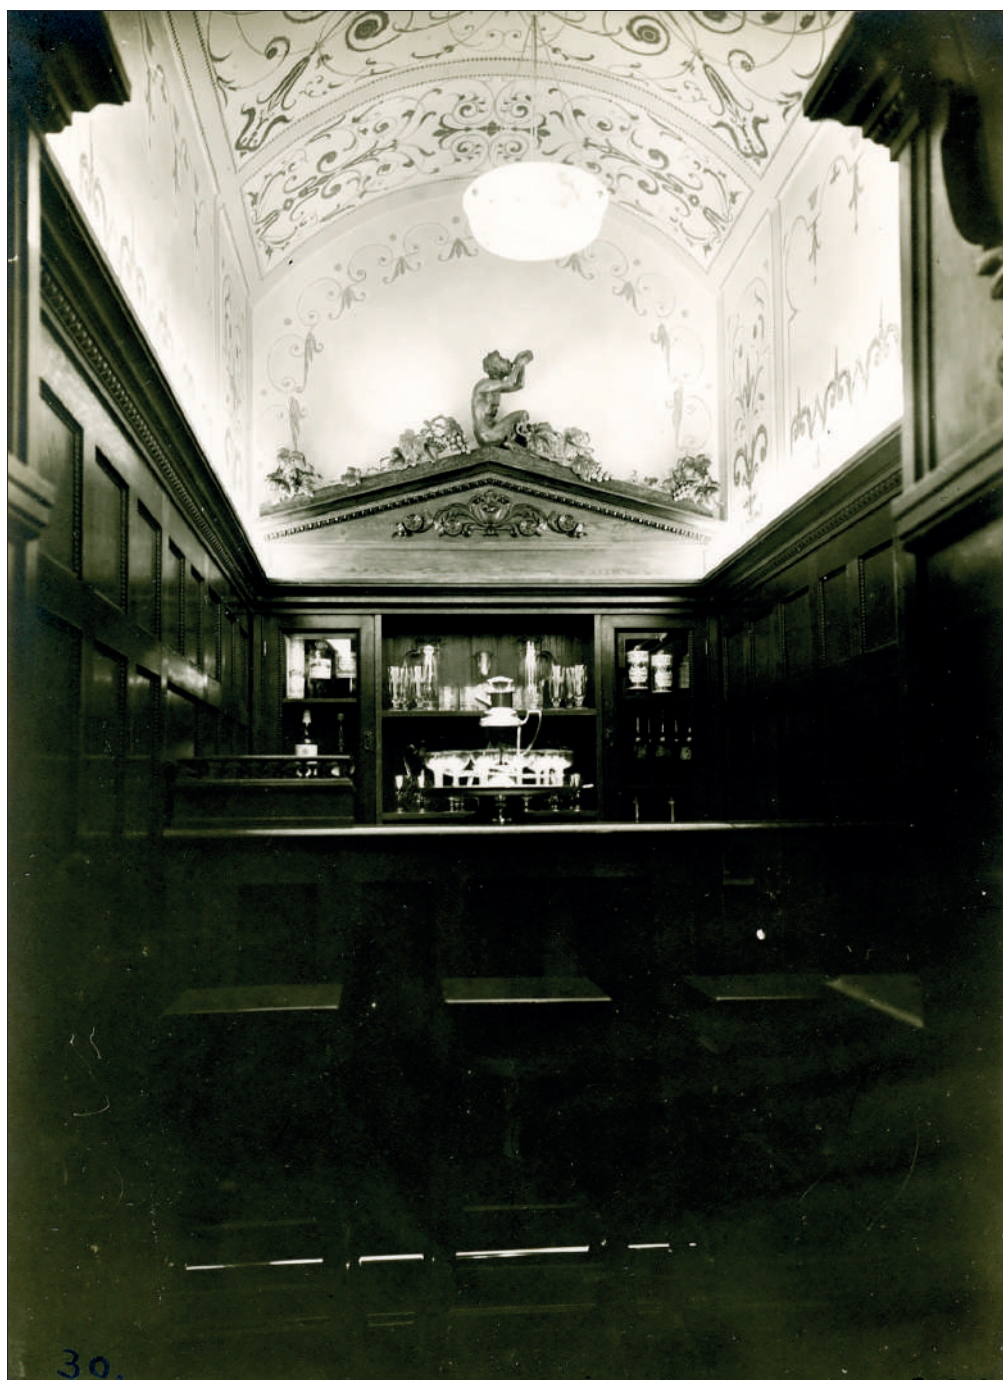
Fig. 2

The bar, archival photograph, Łańcut Castle Museum Archive

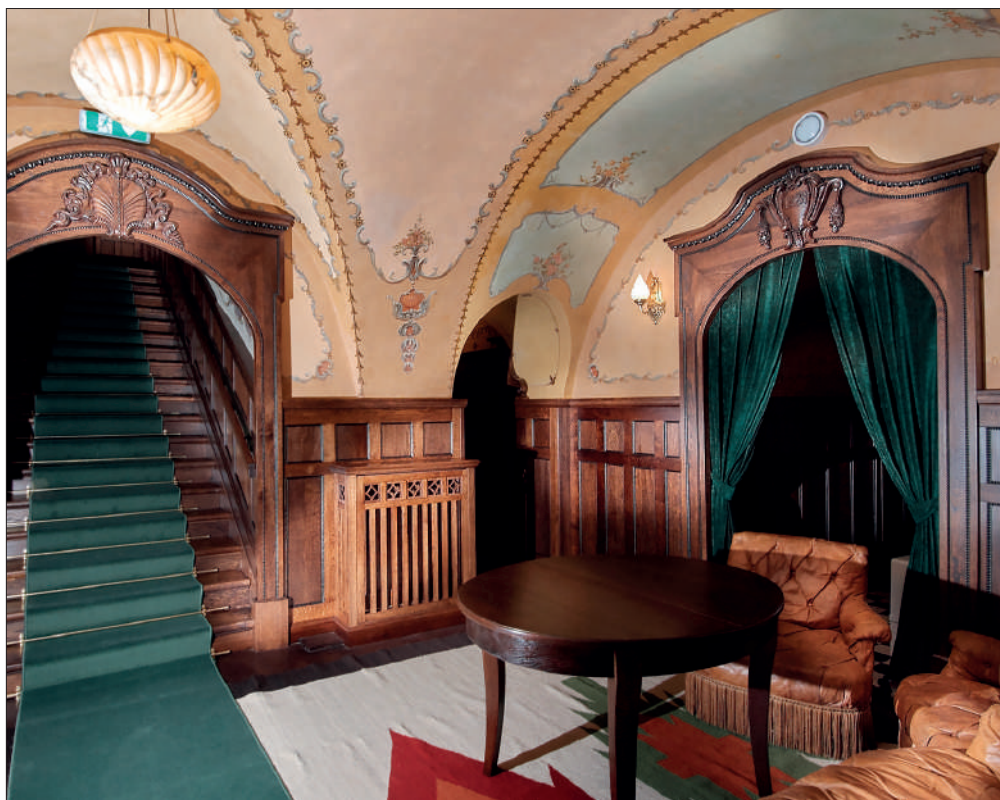
Fig. 3

Resting room after  
conservation

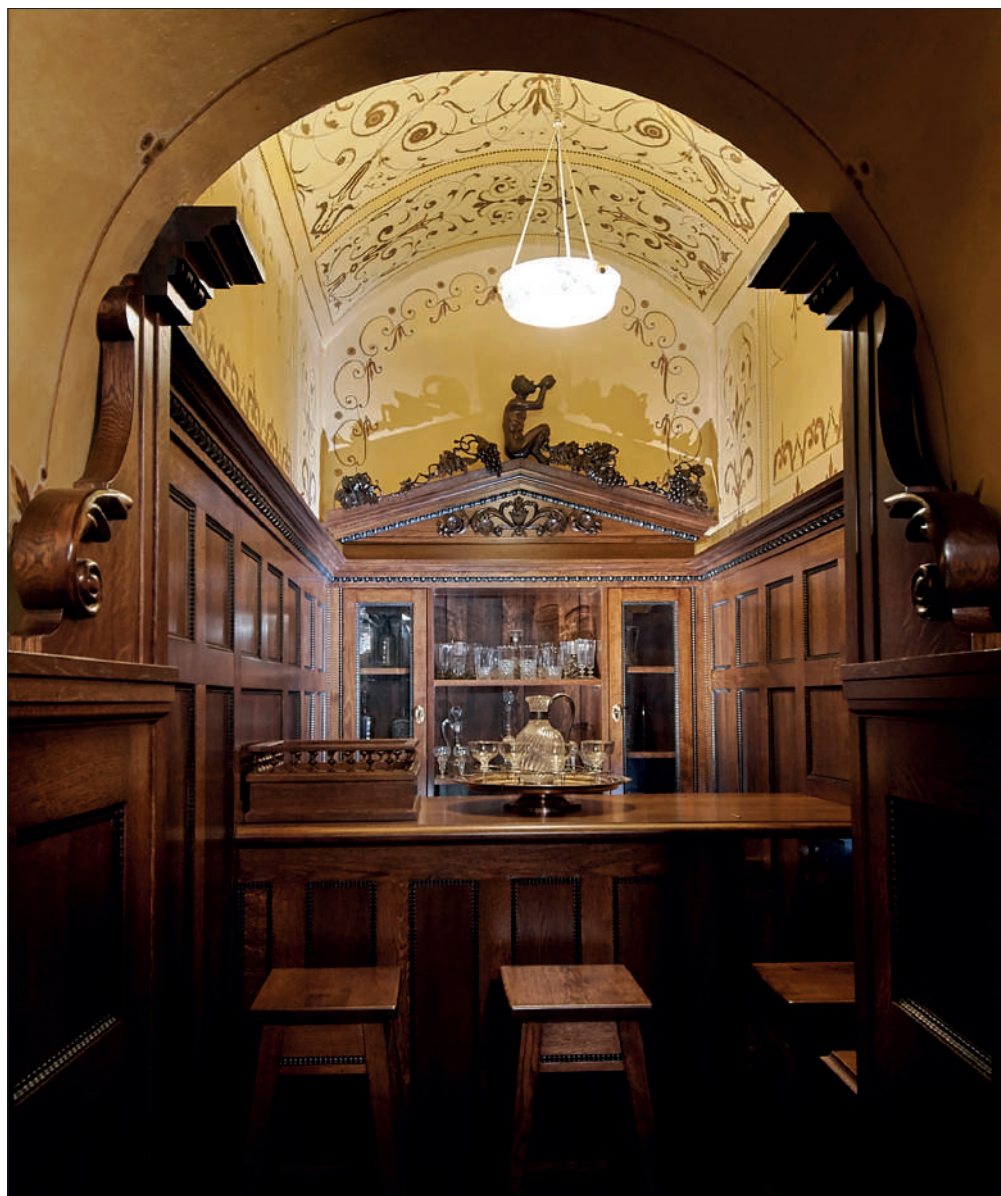
Fig. 4

The bar after conservation

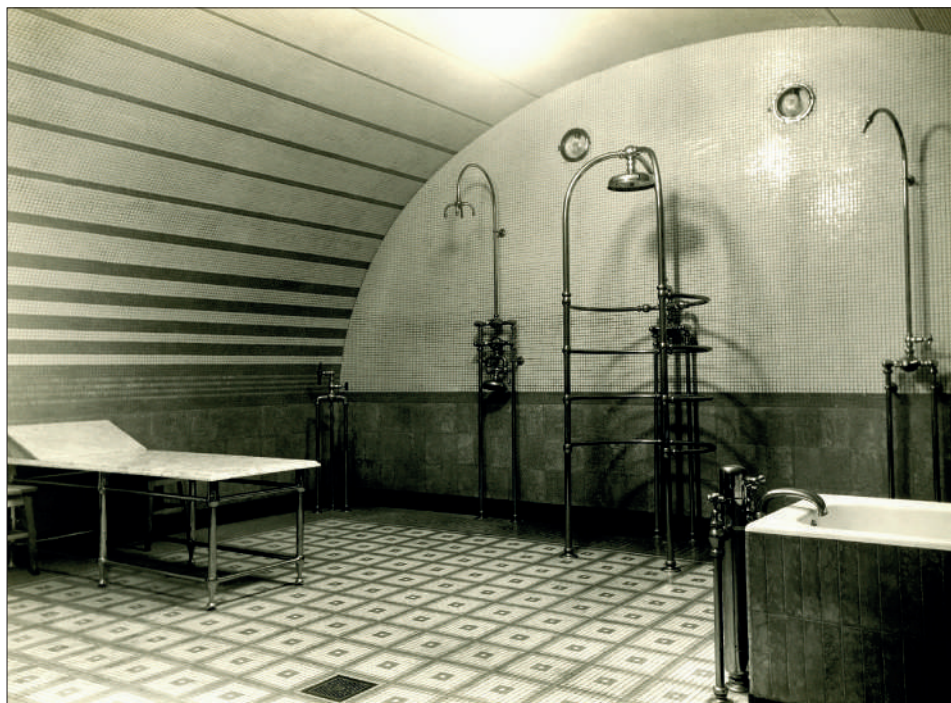
Fig. 5

Bathing area, archival photograph

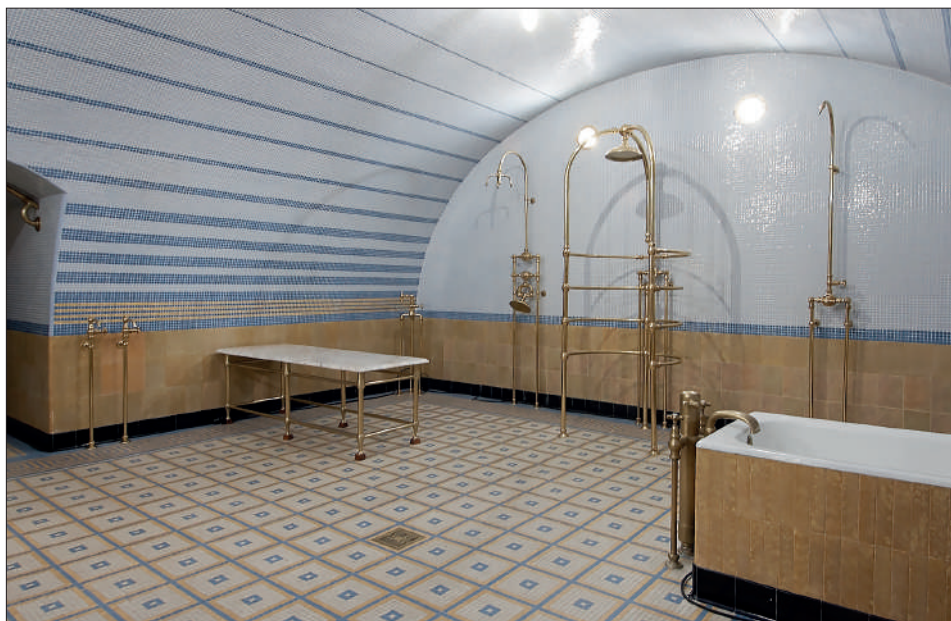
Fig. 6

Bathing area after conservation

electroplating method.<sup>68</sup> During the works, attempts were made to restore the nickel layer without dismantling the brass elements, but the results were hardly satisfactory. The committee decided to preserve the brass layer on the door and to use this colour for other metal elements in the area, even though it is likely that most of the fittings were nickel-plated, and therefore silver-coloured. What is more, the electroplating protected them from the water.
